STS-107 *Columbia* Reconstruction Report

STS-107 Columbia Reconstruction Report

NSTS-60501

JUNE 30, 2003

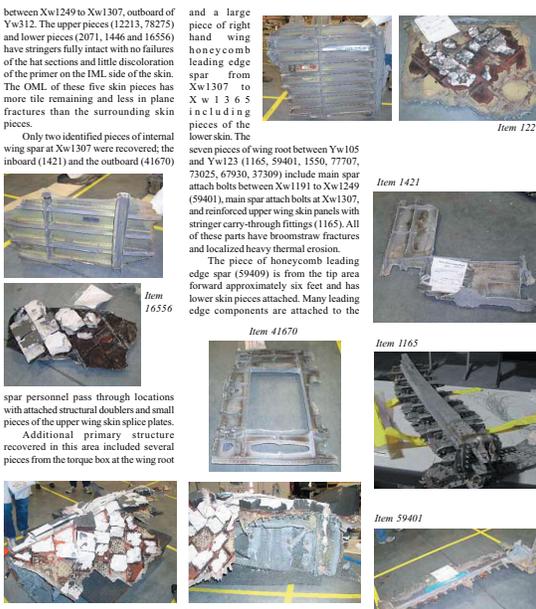
between Xw1249 to Xw1307, outboard of Yw312. The upper pieces (12213, 78275) and lower pieces (2071, 1446 and 16556) have stringers fully intact with no failures of the hat sections and little discoloration of the primer on the IML side of the skin. The OML of these five skin pieces has more tile remaining and less in plane fractures than the surrounding skin pieces.

Only two identified pieces of internal wing spar at Xw1307 were recovered; the inboard (1421) and the outboard (41670)

and a large piece of right hand wing honeycomb leading edge spar from Xw1307 to Xw1365 including pieces of the lower skin. The seven pieces of wing root between Yw105 and Yw123 (1165, 59401, 1550, 77707, 73025, 67930, 37309) include main spar attach bolts between Xw1191 to Xw1249 (59401), main spar attach bolts at Xw1307, and reinforced upper wing skin panels with stringer carry-through fittings (1165). All of these parts have broomstraw fractures and localized heavy thermal erosion.

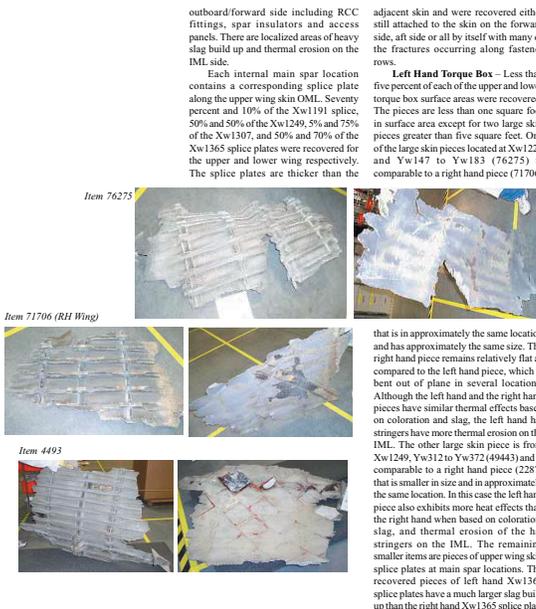
Each internal main spar location contains a corresponding splice plate along the upper wing skin OML. Seventy percent and 10% of the Xw1191 splice, 50% and 50% of the Xw1249, 5% and 75% of the Xw1307, and 50% and 70% of the Xw1365 splice plates were recovered for the upper and lower wing respectively. The splice plates are thicker than the

adjacent skin and were recovered either still attached to the skin on the forward side, aft side or all by itself with many of the fractures occurring along fastener rows.
